**Flood Control Project Maintenance
Levee Inspections**

Fall 2011 Levee Maintenance Deficiency Summary Report

Sacramento River Basin

Sacramento Maintenance Yard Sacramento Bypass

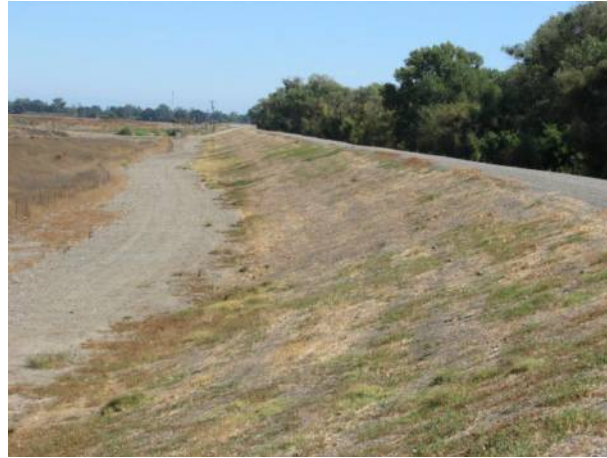
johngw_f_20111024_418.jpg

Levee Mile Report Line	1
Start Levee Mile	0.04
End Levee Mile	1.72
Location	Land Side
Category	Earthen Levee
Item	Vegetation

The vegetation is less then 12 inches. Fall 2011.

LMR No.	Levee Mile		Category	Item	Location *	Rating **	Action/Comment	GPS Latitude/Longitude		Issue No.
	Start	End						Start	End	Photo
1	0.04	1.72	Earthen Levee	Vegetation	LS	A	Remove the wild growth other than native grasses from the levee slopes.	38.607009 ° 121.560530 °	38.599448 ° 121.590030 °	3 Y
2	0.43	1.72	Earthen Levee	Vegetation	WS	A	Remove the wild growth other than native grasses from the levee slopes.	38.604856 ° 121.567290 °	38.599448 ° 121.599448 °	4 Y

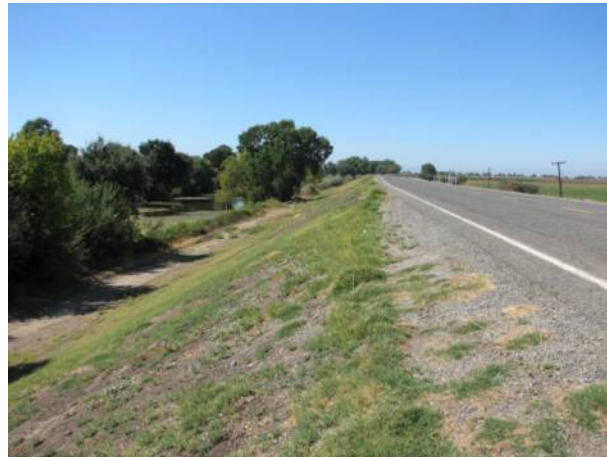
johngw_f_20111024_419.jpg

Levee Mile Report Line	2
Start Levee Mile	0.43
End Levee Mile	1.72
Location	Water Side
Category	Earthen Levee
Item	Vegetation

The vegetation is less then 12 inches.Fall 2011.

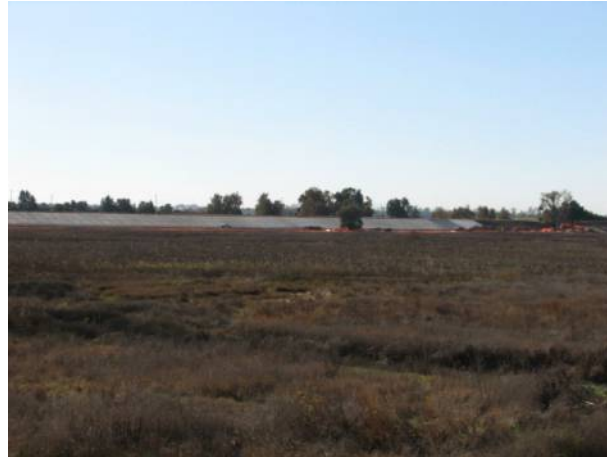
johngw_f_20111130_585.jpg

LMR No.	Levee Mile		Category	Item	Location *	Rating **	Action/Comment	GPS Latitude/Longitude		Issue No.
	Start	End						Start	End	Photo
1	0.00	1.78	Earthen Levee	Encroachments		W	Equipment Inspector Comments: The levee is under construction of a slurry wall and new concrete apron. Unable to inspect the levee.	°	°	43
								°	°	Y

Levee Mile Report Line	1
Start Levee Mile	0.00
End Levee Mile	1.78
Location	
Category	Earthen Levee
Item	Encroachments

A view of the apron at the west end of the project.

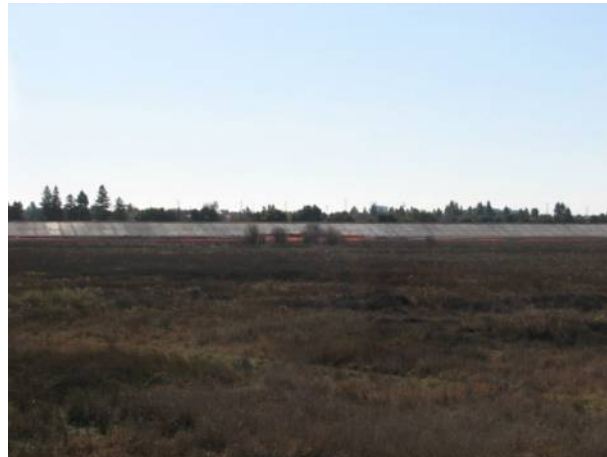
johngw_f_20111130_586.jpg

Levee Mile Report Line	1
Start Levee Mile	0.00
End Levee Mile	1.78
Location	
Category	Earthen Levee
Item	Encroachments

A view of the center of the new levee and apron.

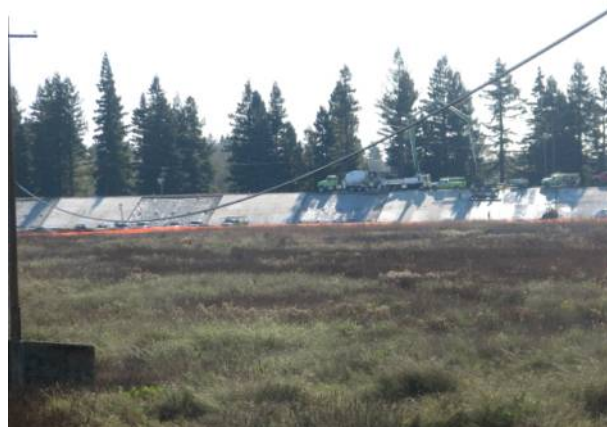
johngw_f_20111130_587.jpg

Levee Mile Report Line	1
Start Levee Mile	0.00
End Levee Mile	1.78
Location	
Category	Earthen Levee
Item	Encroachments

The last three areas that need to be poured.
